# Common Failures with Offshore Cable Glands

## Four things you should know about offshore marine cable glands

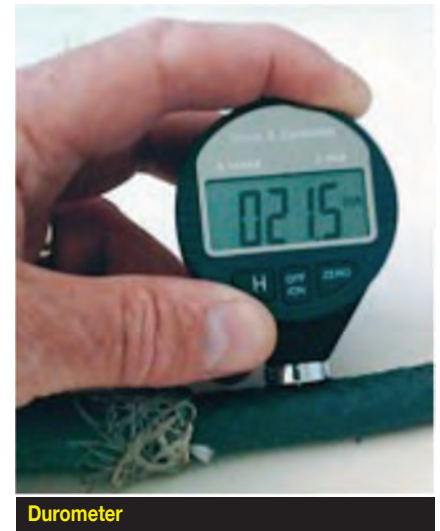
Durometer

The effect of coldflow in cables can vary dramatically with temperature. In tests a BFOU cable bedding at 16°C had an initial durometer reading of 60 Shore A, falling to under 50 Shore A within a few seconds. When the temperature was raised to around 60°C the reading was 25 Shore A, dropping to under 20 Shore A after a few seconds. To put things in perspective, 20 Shore A is about the hardness of a rubber band and 65 Shore A is about the hardness of a car tyre tread or a cable gland seal. No wonder then that cable glands with rubber inner seals pressing on the bedding of BFOU and RFOU cables will cause significant displacement of the bedding. The dramatic change in hardness with temperature also explains why an installation may initially look fine, but later be found to have badly affected cables when the equipment is moved to a hotter climate or when the equipment has been operated and the cable has been warmed by passing a current through it.

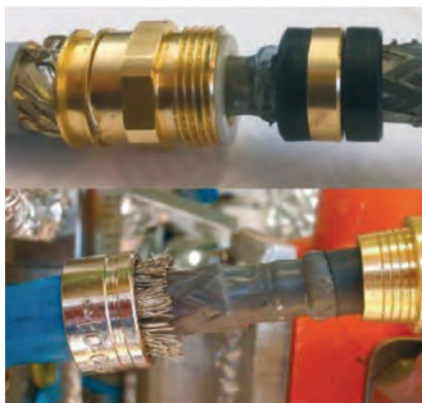
The damage caused by coldflow can be seen in the pictures below.

Coldflow damage

To cut a very long story short, it is only when the cable being used is a BFOU or RFOU type cable made to comply with the NEK 606 specification and even then, the only part of the cable that is affected is the inner bedding and not the outer sheath. The bedding of these cables is a thermoplastic, in common with a lot of cables, but in this case the bedding material is relatively soft. Softer in fact than a cable gland seal so that when the two of them are pressed together, it is the cable bedding and not the cable gland seal that is displaced (this is after all what we mean by one thing being harder than the other). Coldflow can be tested using a simple hardness tester (a Durometer). If the bedding of the cable is less hard than the cable gland seal then there is a risk that the cable is at risk of significant coldflow. If the durometer is left in contact with the cable bedding and the durometer reading continues to fall then the cable bedding is definitely at risk of significant coldflow. It gets worse...

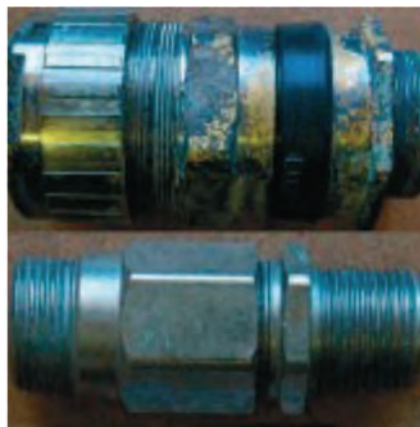
Plating thickness is important, but plating quality is also critical, and for offshore applications the nickel plating should be marine grade electroless nickel plating. The photos below show the results of a 500 hour salt spray test carried out according to ASTM B117:2011 followed by a sulphur dioxide test to ISO 6988. Both of the cable glands looked bright and shiny before the test. The example with a claimed 4 microns of plating lost some of its plating during the test and what was left was severely discoloured and degraded. The sample with 12 microns of marine grade electroless nickel plating was essentially unaffected by the test.

Image 1: 4 microns of nickel plating, Image 2: 12 microns of nickel plating

only a few microns of nickel plating then the plating can only be considered as 'decorative'. If the plating is 10 microns thick or more then it is 'protective'.
